Restoration of the Eggrank bend at the Thur River in Andelfingen ZH

M. Mende & M. Müller
IUB Engineering Ltd., Bern

P. Sieber & M. Oplatka
Building Department, Canton of Zurich

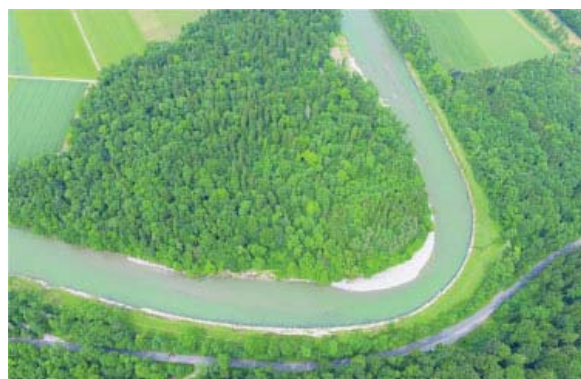
Initially, this channelized bend was characterized by unnaturally high flow velocities, a bad connection between the river and the adjacent lands and a lack of flow structuring elements. The river reach presented a pronounced bend scour with flow depths up to four meters at low water discharge. However, due to high flow velocities and the lack of sheltering zones fishes were either drifted already at mean discharge ($MQ = 47 \text{ m}^3/\text{s}$) or the animals had to spend a lot of energy to keep their position.

Figure 1. Aerial photo of the Eggrank Bend at mean discharge situation before restoration.

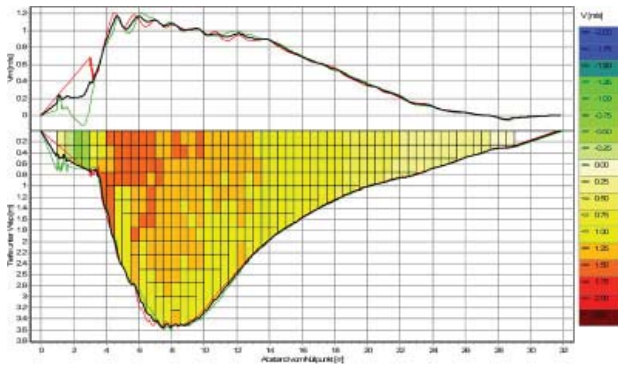
Figure 9. Flow velocities in cross section no. 7, initial state, results from ADCP-measurements.

Results from the first monitoring campaign (initial state) show that this general statement is entirely matching the flow behavior in the Eggrank Bend. In the curve apex (cross section no. 7, Figure 8) a scour zone of about 3.6 m depth had formed during mean discharge periods and concentrated discharge to this part of the section (Figure 9). Consequently, the water table width is only 31 m and thus considerably smaller compared to a width of some 50 m in the neighboring up- and downstream zones (Figure 1). Flow velocities in the scour area reach between 1.0 and 1.5 m/s at mean discharge, with maximum values close to the left bank, as expected.

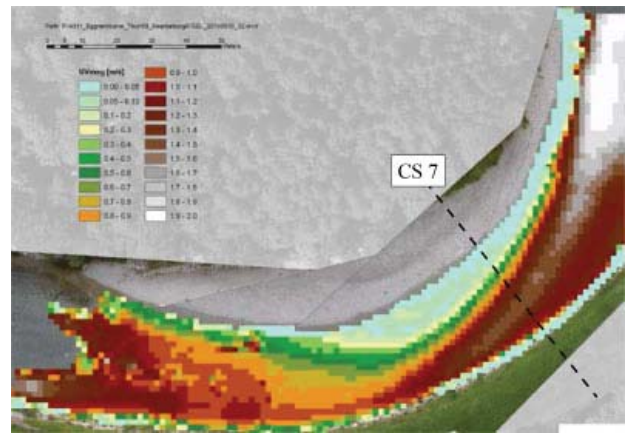
ADCP-measurements correlate well with the LSPIV-records. Figure 10 illustrates the flow concentration toward the outer bank and the low flow regime at the inner bank.

Figure 10. Surface flow velocities at the Eggrank Bend, initial state. Dashed line: approximate location of cross section no. 7 (LSPIV, source: VAW, adapted).

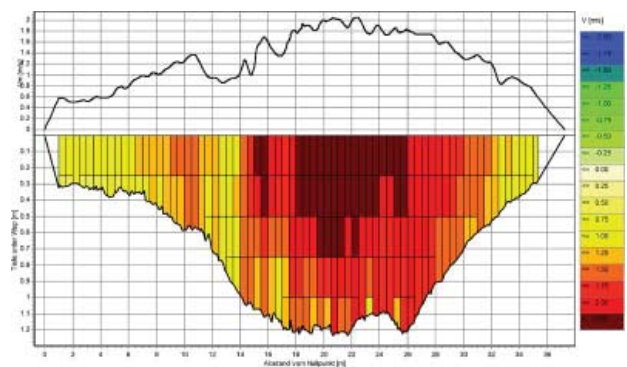
Figure 11. Flow velocities in cross section no. 7, three months after restoration, results from ADCP-measurements.

be observed. Water table width has increased to 37 m and is now about 6 m larger than before restoration. Remarkably, flow velocities have increased to more than 2.0 m/s with maximum values in the center of the cross section. Distribution of flow velocity has become more inhomogeneous which corresponds to increased flow diversity. However, the system is still strongly influenced by the recent construction activities in the river and important changes are expected at mid-term. Especially, it is expected that the wetted cross section will grow larger due to small erosions along the micro groin head as well as erosion at the inner bank. Consequently, flow velocities should decrease.

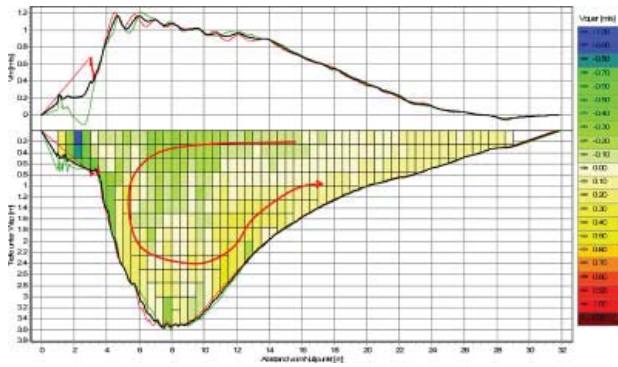
The shift of maximum flow velocities to the outer bank is provoked by the interaction of the main flow with the curve-induced secondary currents. Figure 12 illustrates the measured transversal velocities at cross section no. 7 for the initial state before restoration. At the surface, transversal currents are directed toward the outer bank while deep currents are pointing toward the inner bank. The resulting secondary flow is drafted by the arrow in Figure 12.

Figure 12. Transversal velocities (measured perpendicularly to the cross section) in cross section no. 7, initial stage; negative transversal velocities are directed to the left, positive ones to the right.

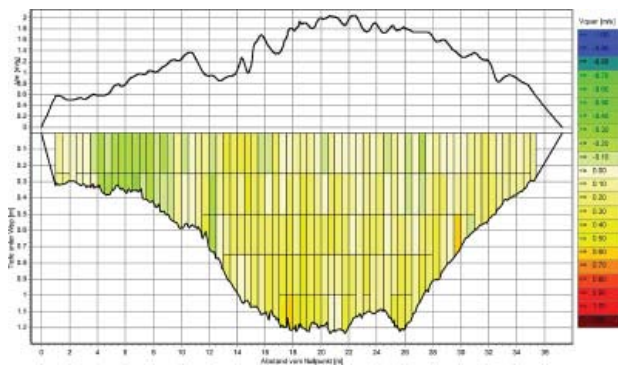
Contrary to the initial state, today's situation does not reveal any important secondary current (Figure 13). This explains the more equilibrated flow velocity distribution over the cross section. Whether

Figure 13. Transversal velocities (measured perpendicularly to the cross section) in cross section no. 7, three months after restoration; negative transversal velocities are directed to the left, positive ones to the right.

this phenomenon is caused by the implemented micro groins or mainly influenced by the large quantities of bed material moved during the construction phase cannot be concluded yet. The third monitoring campaign will provide more detailed information about this aspect.

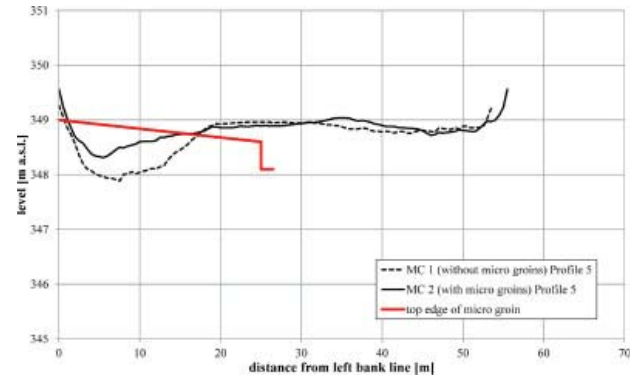
Figure 14 reveals the bed geometry development at cross section no. 5 located at the upstream end of the Eggrank Bend in the area of the new embankment along the left shoreline (about 5,000 m³, Figure 2). The river bed has only marginally developed compared to the initial state. Even in the area of the filling, the river bed level is only some 50 cm higher than before. This leads to the conclusion that a main part of the embankment has already been eroded during minor flood events since the end of construction works.

Figure 14. River bed geometry at cross section no. 5, recorded by ADCP before (dashed line) and after restoration (continuous line). The bold continuous line represents the upper edge of the implemented micro groin.

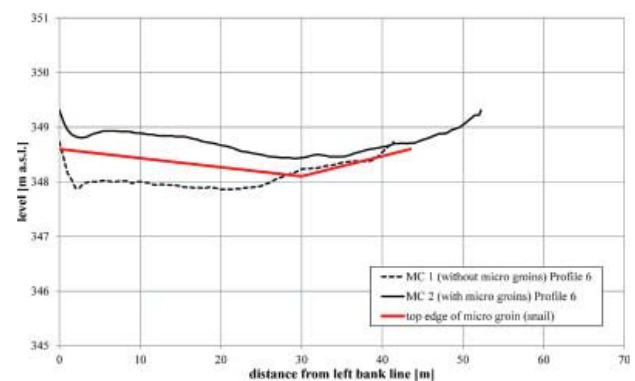
Apparently, the bed material deposited in the area of the snail shaped groin (cross section no. 6, Figure 15). This section presents deposits in the outer bank zone

Figure 15. River bed geometry at cross section no. 6, recorded by ADCP before (dashed line) and after restoration (continuous line). The bold continuous line represents the upper edge of the implemented micro groin.

of almost 1.0 m which lead to a complete cover of the snail shaped groin.

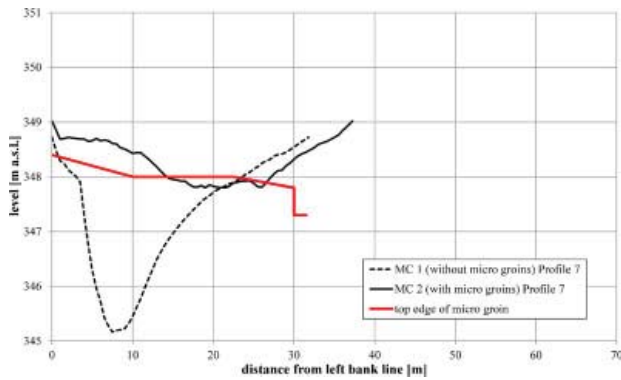
In the area of the initially deepest bend scour (cross section no. 7), the river bed is now located up to 3.5 m higher than before restoration (Figure 16). The thalweg has shifted by some 15 m toward the center of the cross section. Due to the filling in the scour zone combined with the material transported downstream from the upstream embankments, the micro groin is mostly covered by gravel. However, it is expected that it will be quickly exposed during major flood events and thus becomes an active flow structuring element.

Figure 16. River bed geometry at cross section no. 7, recorded by ADCP before (dashed line) and after restoration (continuous line). The bold continuous line represents the upper edge of the implemented micro groin.

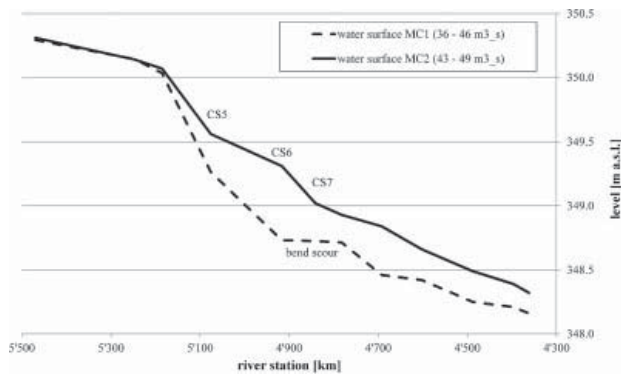
Besides cross sections with river bed levels, a longitudinal profile of the water surface level was generated based on ADCP data (Figure 17). As discharges during the two monitoring campaigns were very similar, a good comparability between water levels before and after construction is assured. After restoration, the water level in the considered area has increased by up to 60 cm. This is mainly due to the big amount of new additional material in the river.

In the initial bend scour zone which was characterized by a lower slope of the water surface table, the slope has considerably increased which explains the high flow velocities. However, it is expected that future

Figure 17. Longitudinal profile of the water level, recorded by ADCP before (dashed line) and after restoration (continuous line).

water surface tables reach similar levels as in the initial state once the bed material transport has stabilized.

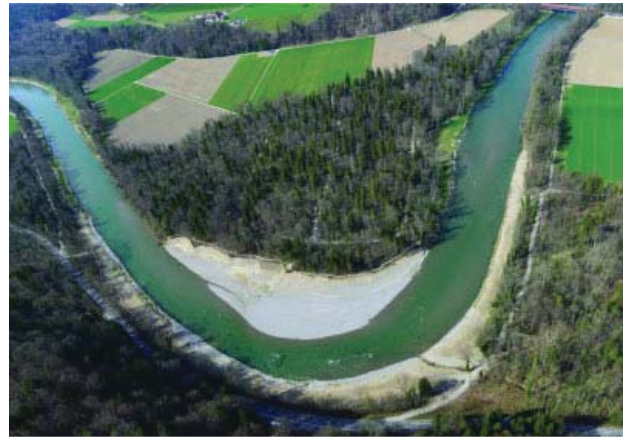
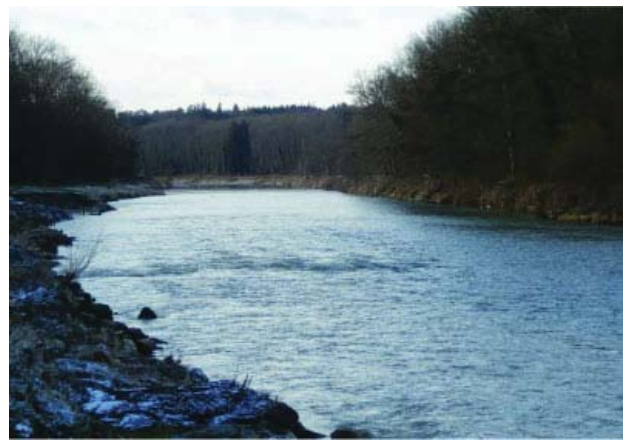
Major parts of the constructed micro groins are gravel-covered today and only partially visible (Figures 18 and 19). This is due to the important quantity of new material in the river which already was redistributed during minor flood events.

Figure 18. Aerial photo of the Eggrank Bend in April 2015, after restoration.

Figure 19. View in downstream direction at cross section no. 10 (micro groin and correspondent flow conditions).

Depending on flood dynamics the initial river bed level is expected to be regained relatively quickly. Consequently, the micro groins will develop their full flow structuring effect. Today's high flow velocities at the outer bank will be reduced and flow diversity enhanced.
