## Immediate Measures Hergiswald Landslide Nr. 6

Municipality of Kriens  
 Kriens Building Department

IUB Engineering AG in consortium

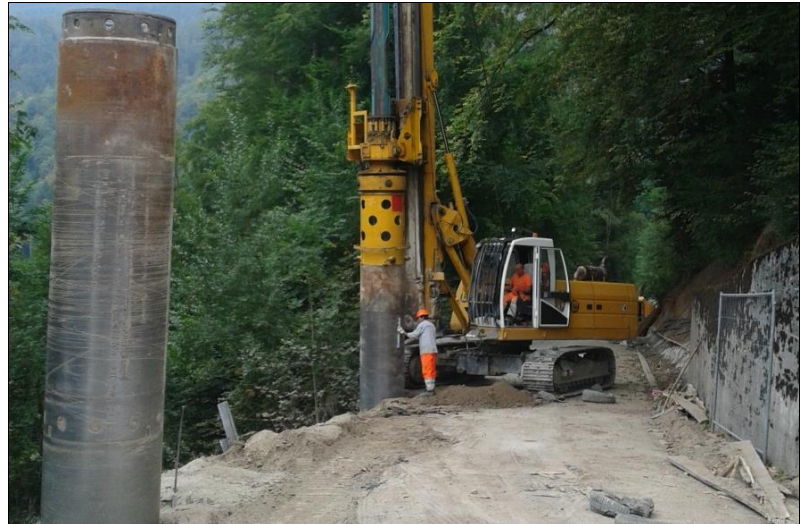
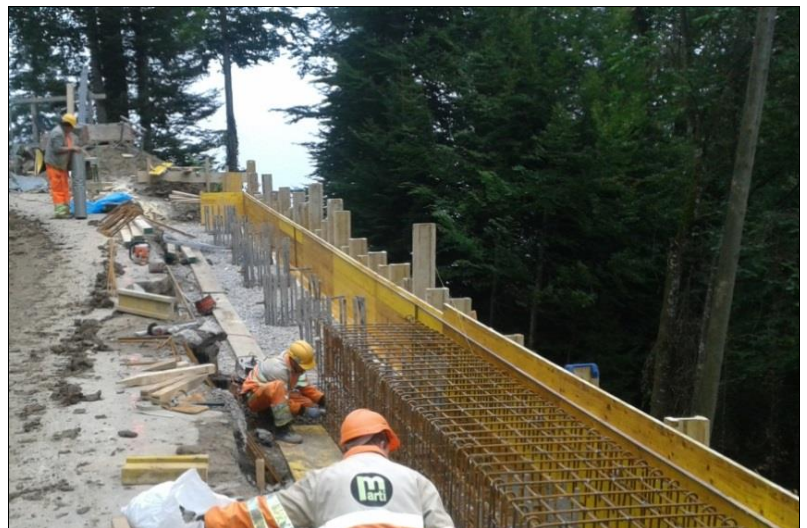
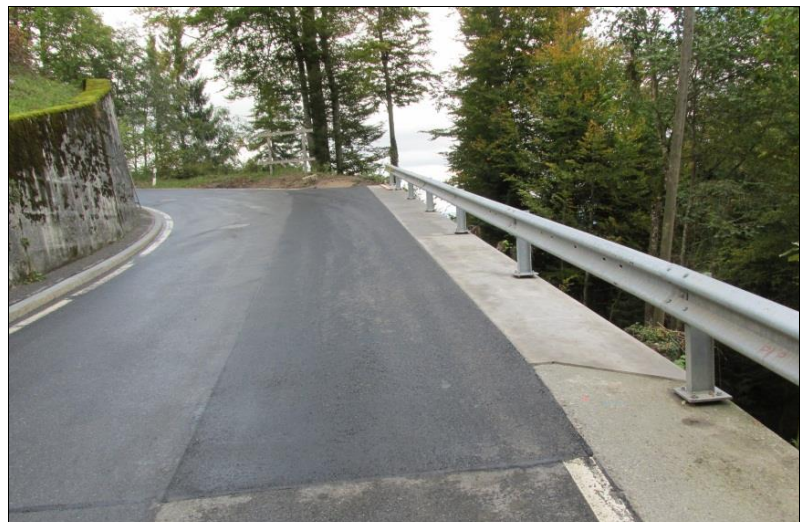
Following heavy rains at the end of July 2014 the edge of the slope on the valley-side of the Hergiswald landslide was in a bad state and slipped. The edge of the slope on the valley-side ran along the village road (Kriens Obernau – Schwarzenberg Holderchäppeli) near the Hergiswald pilgrimage church. An open bored pile wall made of reinforced driven piles and top plates was installed to stabilise the support structure with respect to the road and the existing embankment. The depth of the anchoring of the drilled piles was selected to enable complete fixing in the deep rock. The drilled piles are monolithically connected with the top plates. The crash barrier was fixed to the guide wall.
